SECTION 2. GEOMORPHIC ANALYSIS

This section of the Bank Stabilization Feasibility report presents (1) a review of watershed scale geomorphic processes and (2) a reach scale geomorphic analysis of Chimes Creek. The former describes large scale processes and patterns that may affect channel morphology in the Chimes Creek project reach, while the latter presents key reach scale processes illuminated through a topographic survey, geomorphic inventory, bankfull channel dimension, and plan and profile analysis of the entire project reach (STA 0+00 – 11+50). A geomorphic analysis investigates the relationship between hydrologic components of a watershed such as precipitation and slope and their effect on stream shape (profile, planform). Typical procedures of a geomorphic analysis include quantifying physical features of the watershed (slope, curvature) and reach scale characteristics such width, bank height, erosion sites, channel knickpoints, slope, bars, pools, and riffles. The main goal is to identify the key ongoing

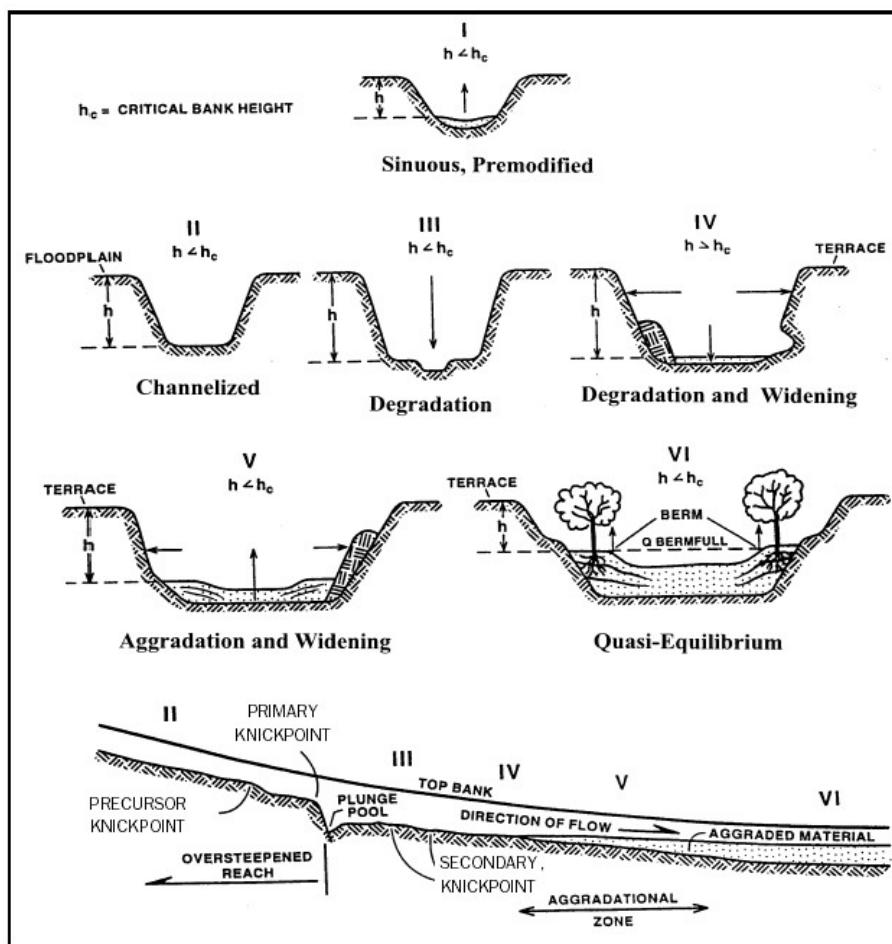
Figure 4B. Conceptual Channel Evolution Model
(Schumm, 1984)

As noted in Section 1, changes in discharge, sediment inputs, and overall channel equilibrium occur naturally in a watershed. For urban streams like Chimes Creek, the equilibrium is upset by land-use changes such as increased impervious surface areas, channel straightening, culverting, bank armoring, or changes in grade controls. Channel evolution models can be used to conceptualize how streams adjust to urban development (**Figure 4**). For example, “Urban equilibrium” is a term used to describe a channel that has deviated from its natural or original shape, but has finished adjusting to the urban influences (reduced sediment and increased discharge) affecting it so that it is relatively stable in its profile and planform dimensions. A channel in urban equilibrium, stage VI in **Figure 4** is neither excessively eroding nor depositing sediment and has a healthy riparian corridor established along its edges. From a geomorphic perspective, the channel has achieved a new balance in its bankfull width, depth, slope, and sediment composition in relation to discharge and sediment inputs. In general, the Chimes Creek appears to be between stages III and IV in the context of urban channel evolution.
