## Chimes Creek is a perennial creek originating in the headwaters above the Leona Quarry ...

The following pages document the contamination of this creek -- despite repeated assurances by City officials of BMP's, inspections and permits -- directly caused by grading activities and lack of enforcement of creek protection measures at the Leona Quarry site.

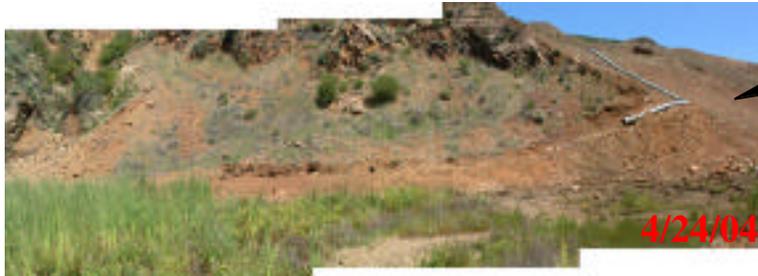
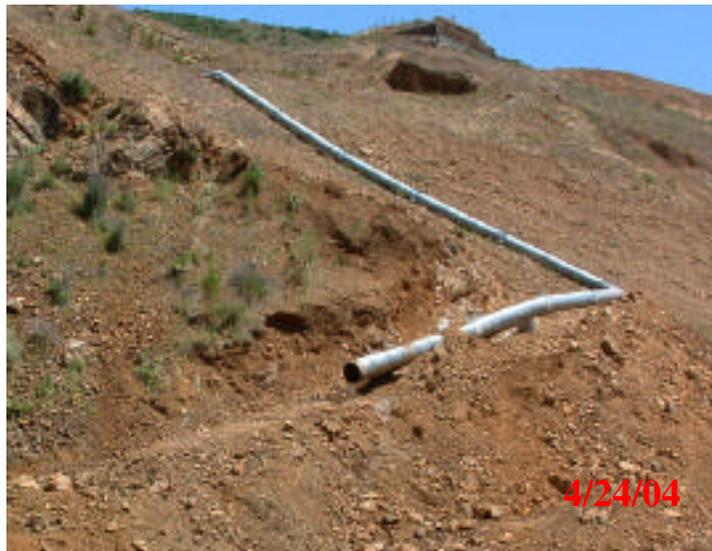
During the first week of April, residents living along Chimes Creek began to notice mud and silt in the water coming down the creek. Coincidentally, tractors and large machinery were assembling at the Quarry site, beginning to trench and dig, and by April 9, had completely removed the asphalt parking lot at the base of the Quarry.

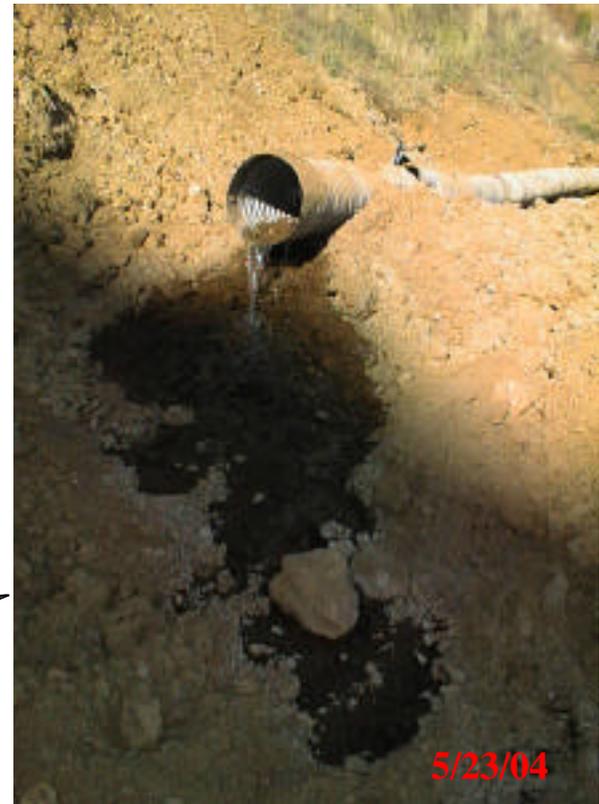
By April 24, 2004, the corrugated metal pipe had been repositioned to dump creek water onto open grade. Presumably, this was in accordance with the approved "Creek Diversion Plan" required to be in place before the Grading Permit could be issued. (The Grading Permit was issued on Fri, 4/23/04)

The water was collecting into a grassy, foamy muddy pond that was drained by two 6" pipes. It was not clear if the two pipes had any filters to keep contaminants out of the flow. Responding to these pictures the following week, City officials claimed the developer had taken care of this matter by connecting the diversion pipe to the drain pipes to prevent the creek from silt contamination.

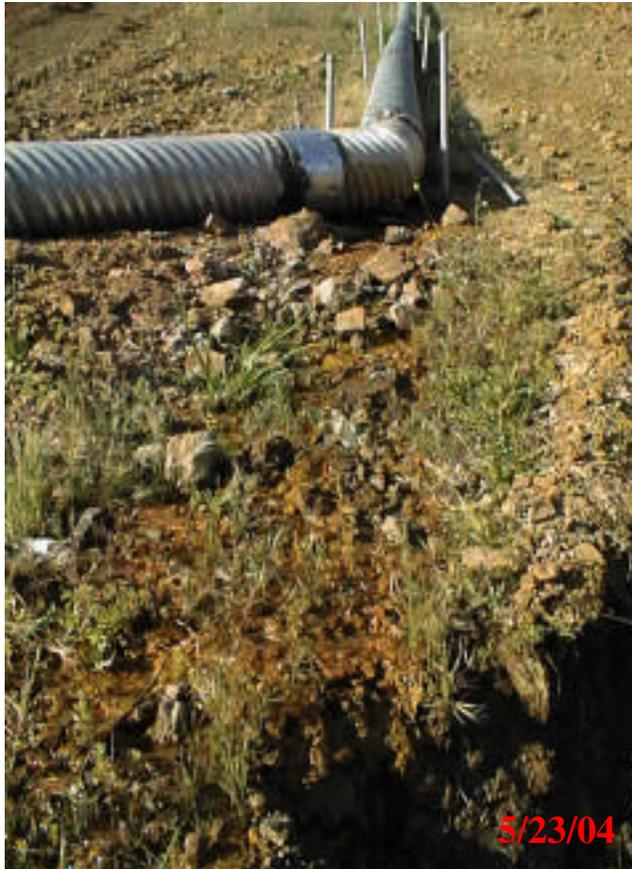
As of May 23, 2004, the creek water continues to dump onto open grade. The creek water somehow collects into a narrow ditch (which has apparently replaced the muddy pond) where it is picked up by the 6" drain pipes. City officials continue to assert that this condition was corrected in late April.

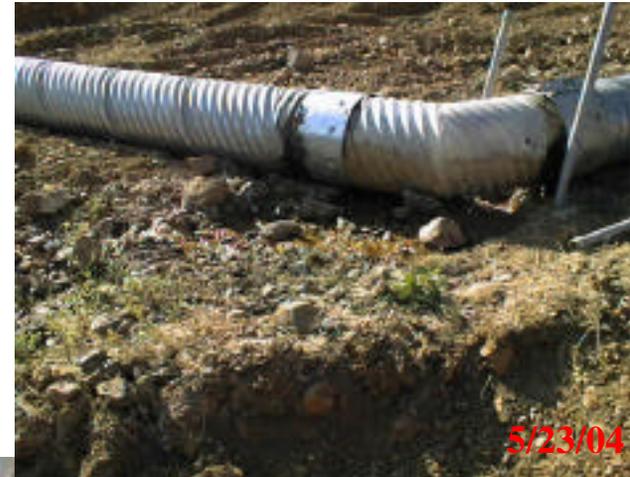
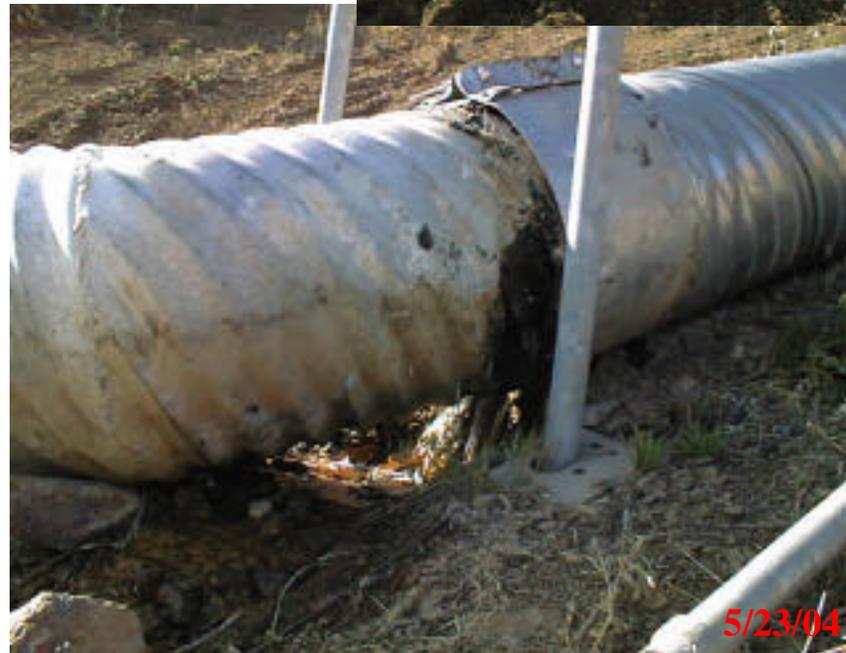
Creek water has been leaking through the pipe joints for some time now, as evidenced by the "lush" growth along its drain path.

**Creek leakage is NOT supposed to be part of the Creek Diversion Plan.**

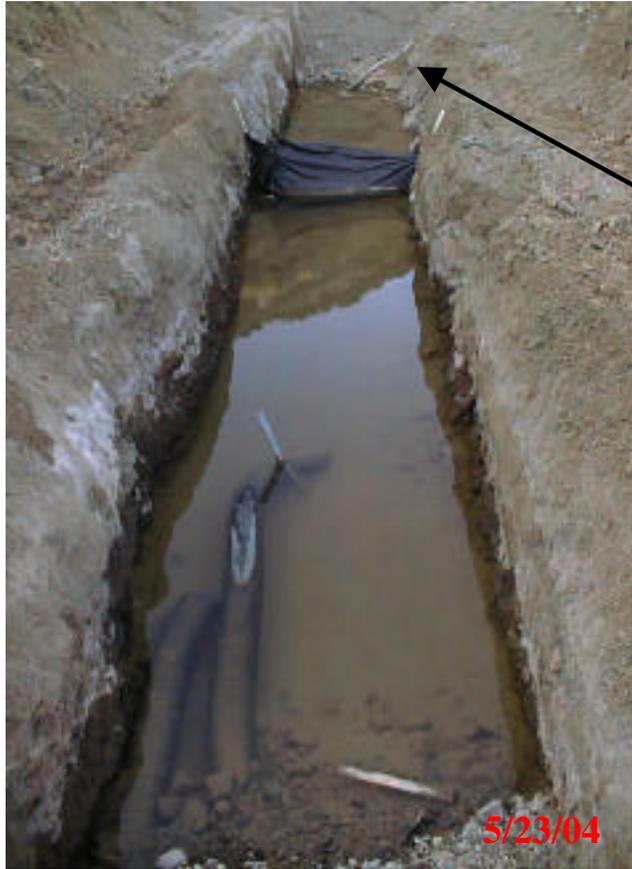
From the narrow ditch, the creek water travels through the 2 black pipes (at the bottom half of the picture) and drains into the storm drain system. A sorry-looking silt fence (BMP??) has been installed to keep the silt out of the intake basin.

In the background is a flex pipe that is used for pumping in muddy groundwater that has accumulated in the excavated pits nearby.

A closeup of the drain pipes show silt and sediment that has settled since Friday afternoon when construction activities ceased for the weekend. This image was taken on Sunday, May 23, 2004.

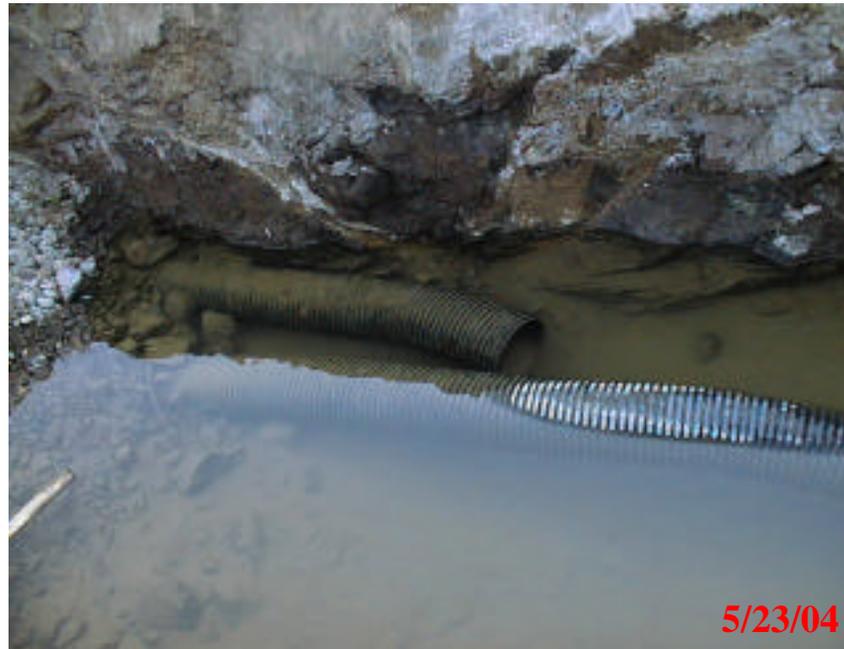
Since April 6, 2004, residents along Chimes Creek have been observing silty, contaminated water coming through the storm drain into the Creek. Periodically the water level fluctuates along with a swelling of reddish brown sediment that leaves its mark at the high point, much like a scum-filled bath tub ring.

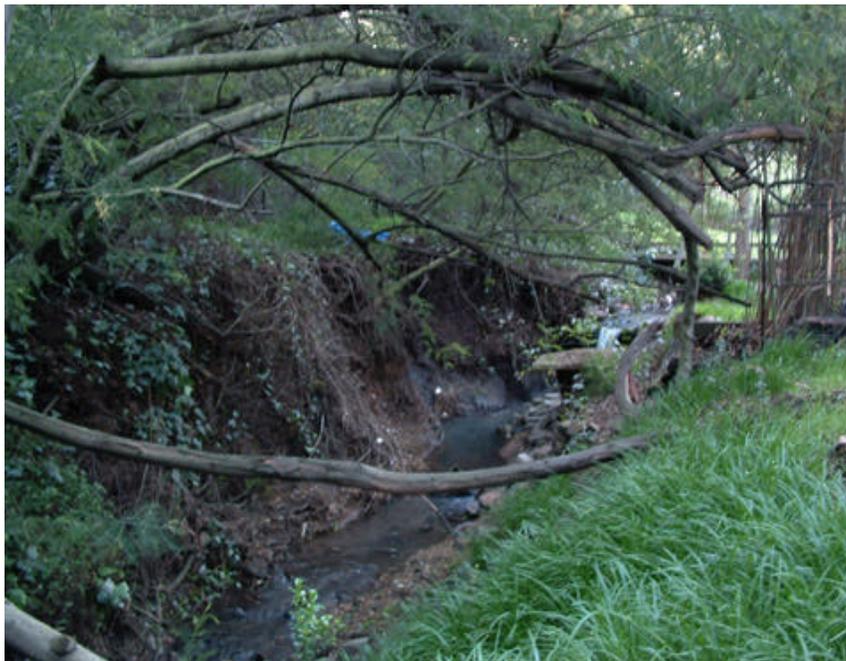
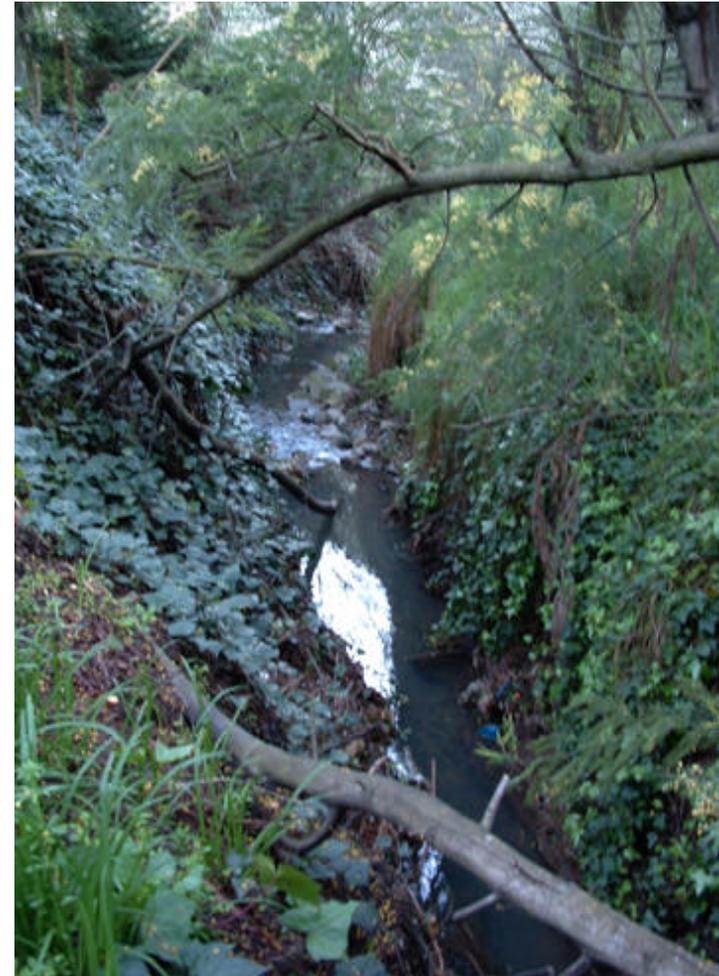
These are images of Chimes Creek in early March this year, one month before grading activities began at Leona Quarry. The water fluctuates with the seasonal rains and storms, but for most of the year during the dry months, it runs constant - - and surprisingly clear. The erosion that can be seen in the picture below is a result of winter storms that overtax the fragile banks. Residents along the creek have periodic work parties to clean up the creek, picking up trash and debris carried through by the storm drains.
