## Chimes Creek is a perennial creek originating in the headwaters above the Leona Quarry ...

The following pages document the contamination of this creek -- despite repeated assurances by City officials of BMP's, inspections and permits -- directly caused by grading activities and lack of enforcement of creek protection measures at the Leona Quarry site.

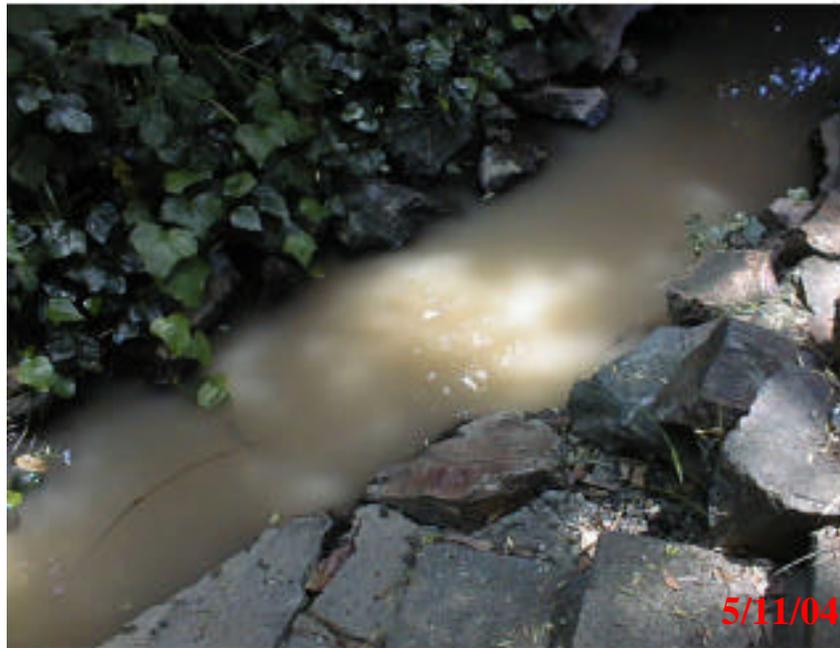
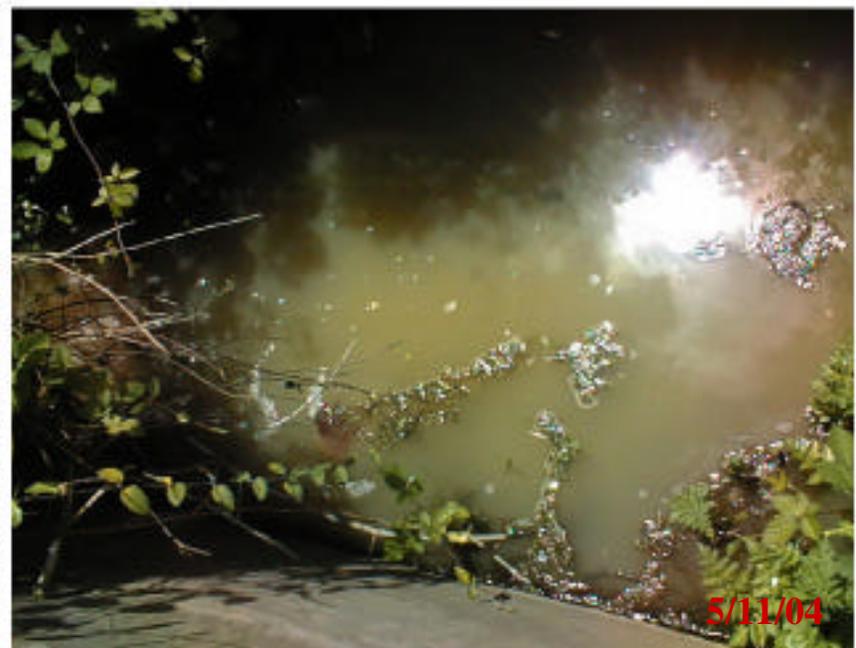
These are images of Chimes Creek in early March this year, one month before grading activities began at Leona Quarry. The water fluctuates with the seasonal rains and storms, but for most of the year during the dry months, it runs constant - - and surprisingly clear. The erosion that can be seen in the picture below is a result of winter storms that overtax the fragile banks. Residents along the creek have periodic work parties to clean up the creek, picking up trash and debris carried through by the storm drains.
